**FINAL**  
**Coal Ash Impoundment –**  
**Specific Site Assessment Report**  
**Westar Energy**  
Jeffrey Energy Center

Submitted to:  
**Lockheed-Martin Corporation**  
2890 Wood Bridge Avenue  
Building 209 BAYF  
Edison, NJ 08837

Submitted by:  
**GEI Consultants, Inc.**  
6950 South Potomac Street, Suite 300  
Centennial, CO 80112

September 2009  
Project 091330

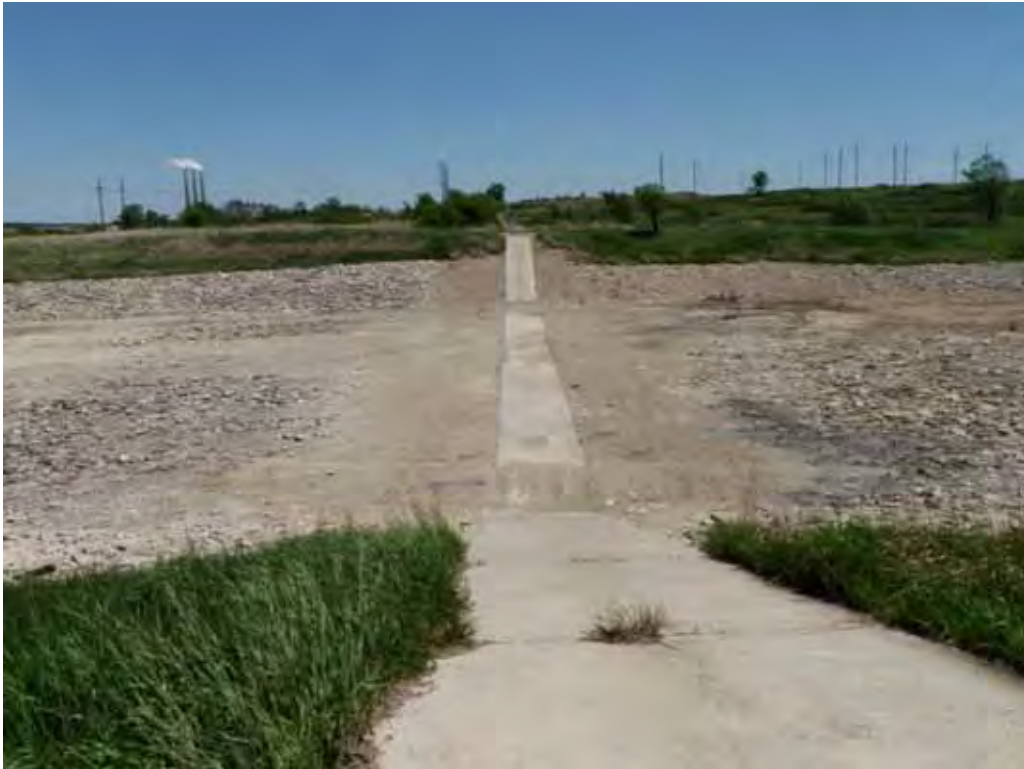
The limestone riprap both upstream and downstream of the concrete control crest showed extensive deterioration along the entire length of the control crest (Photos 1 – 4). Minor concrete spalling was also observed at a few locations on the top of the concrete control crest. The approach channel to the emergency spillway was also observed to have extensive riprap deterioration showing significant variability in riprap size (Photos 5-8). The riprap lining on the channel downstream of the control crest showed less deterioration and more consistent riprap sizes (Photo 9). Several small trees were observed at the exit of the riprap lined spillway channel which should be removed (Photo 10).

**Photo 1- Emergency Spillway - Looking across the emergency spillway control crest standing on road.**

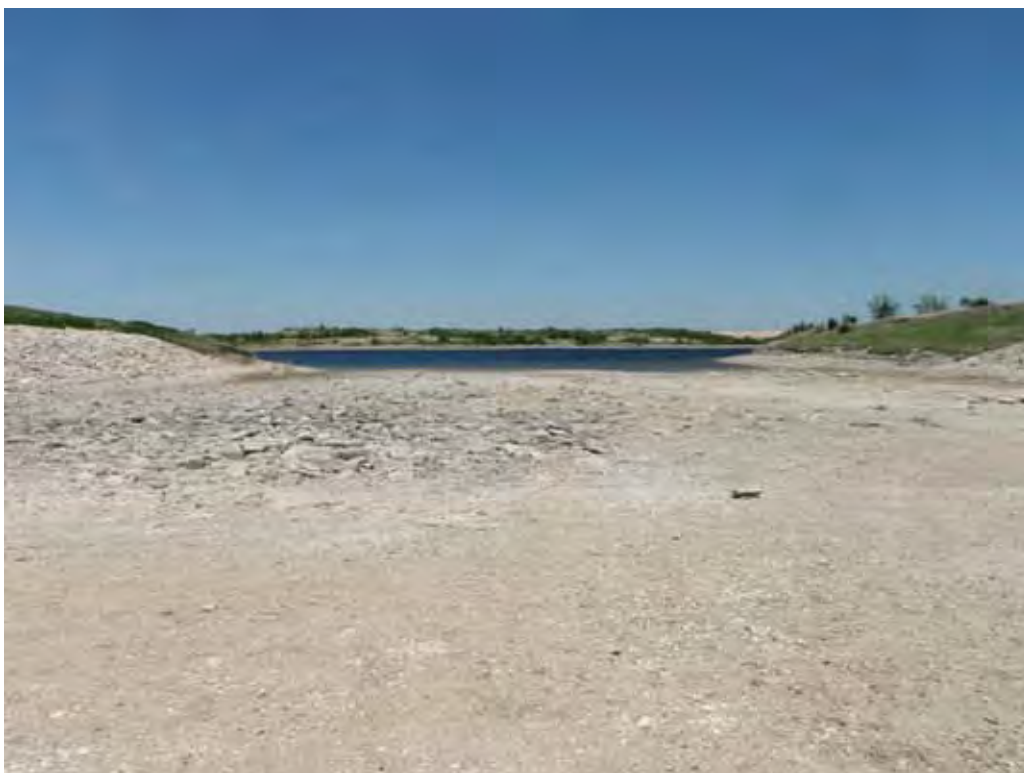
**Photo 2 - Emergency Spillway - Looking upstream, towards reservoir, standing near center line of spillway on control crest.**

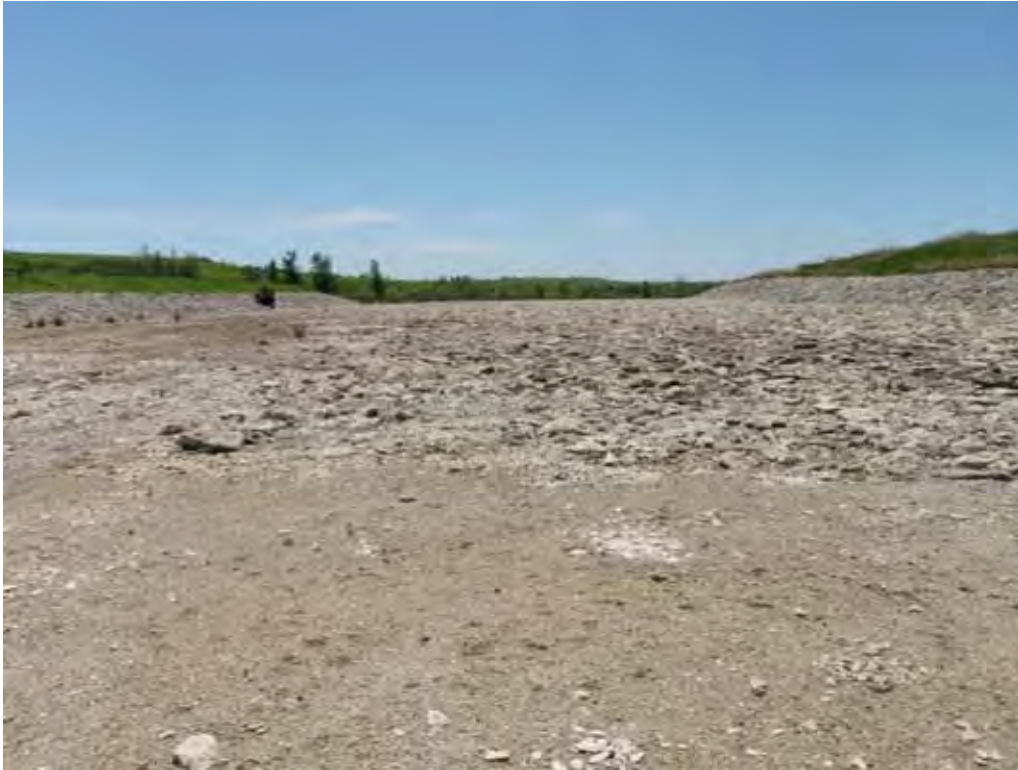
**Photo 3 - Emergency Spillway - Looking downstream, towards channel, standing near centerline of spillway on control crest.**

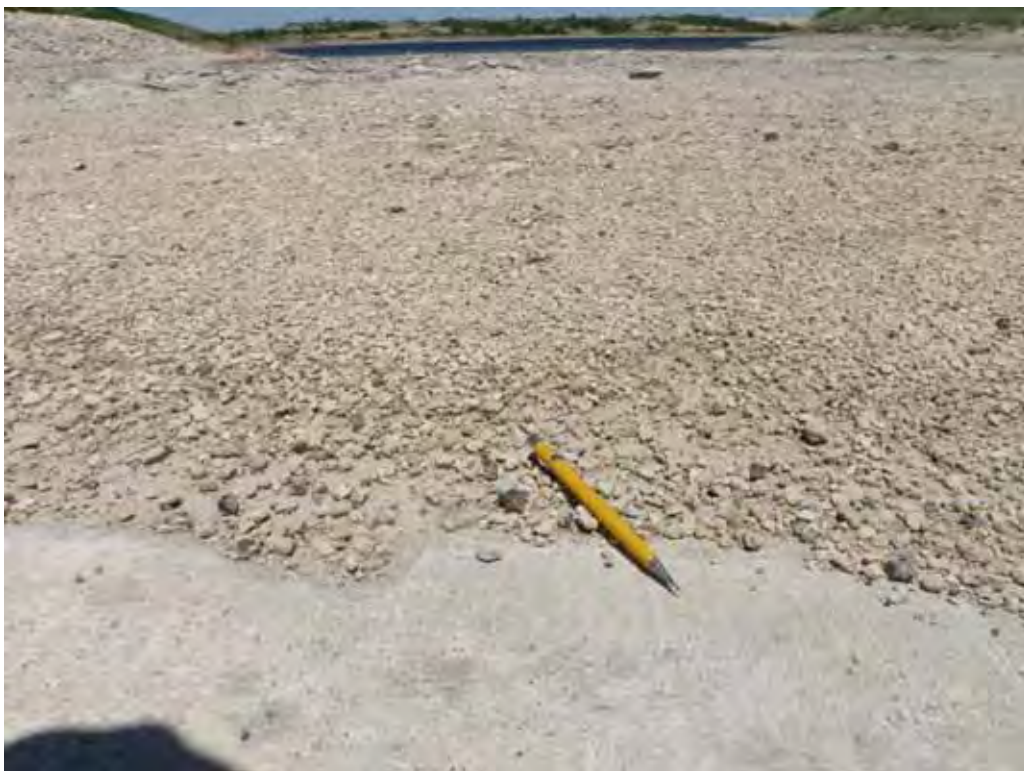
**Photo 4 - Emergency Spillway – Detail and scale of degraded riprap protection near spillway control crest.**

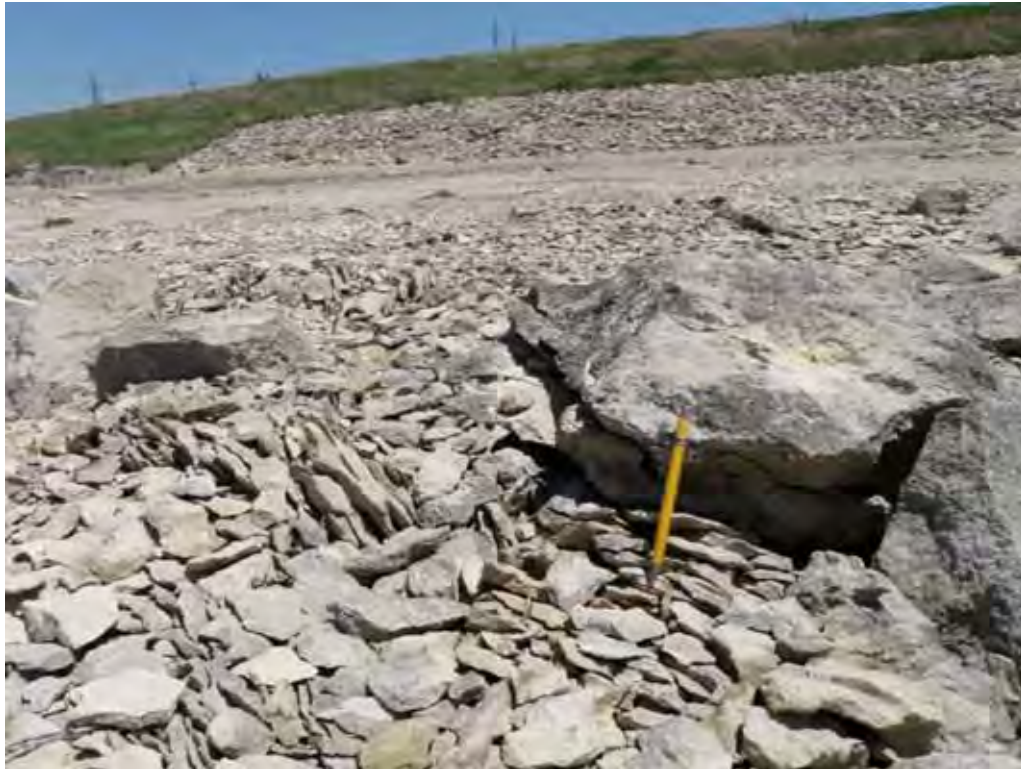
**Photo 5 - Emergency Spillway – Detail and scale of riprap protection size variability near centerline of spillway approach channel.**

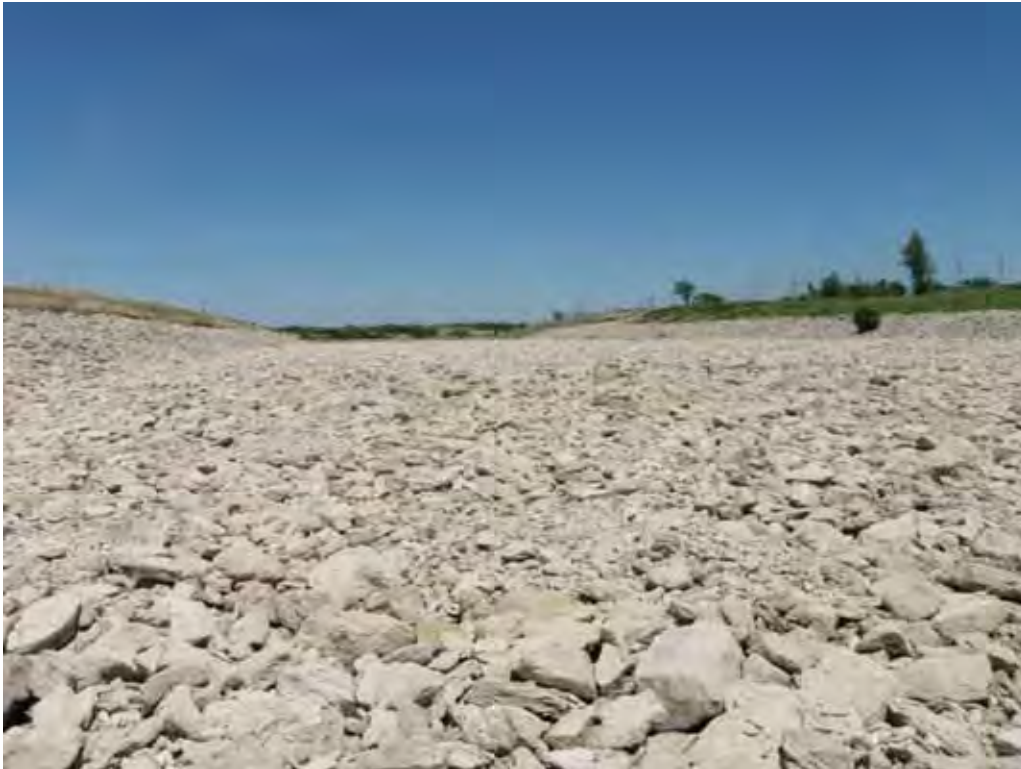
**Photo 9 - Emergency Spillway – Looking upstream near the end of the riprap lined channel. (Note: Small tree on left side slope of spillway)**

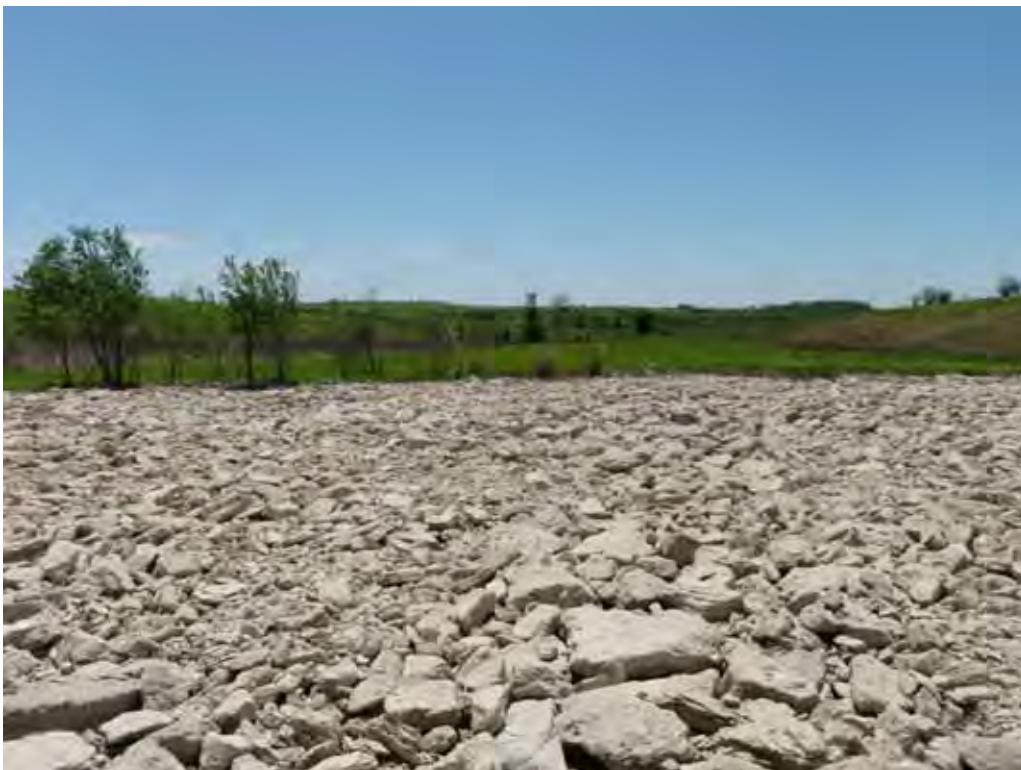
**Photo 10 - Emergency Spillway – Looking downstream at the end of riprap lined channel towards grass lined channel. (Note: Small trees in channel)**

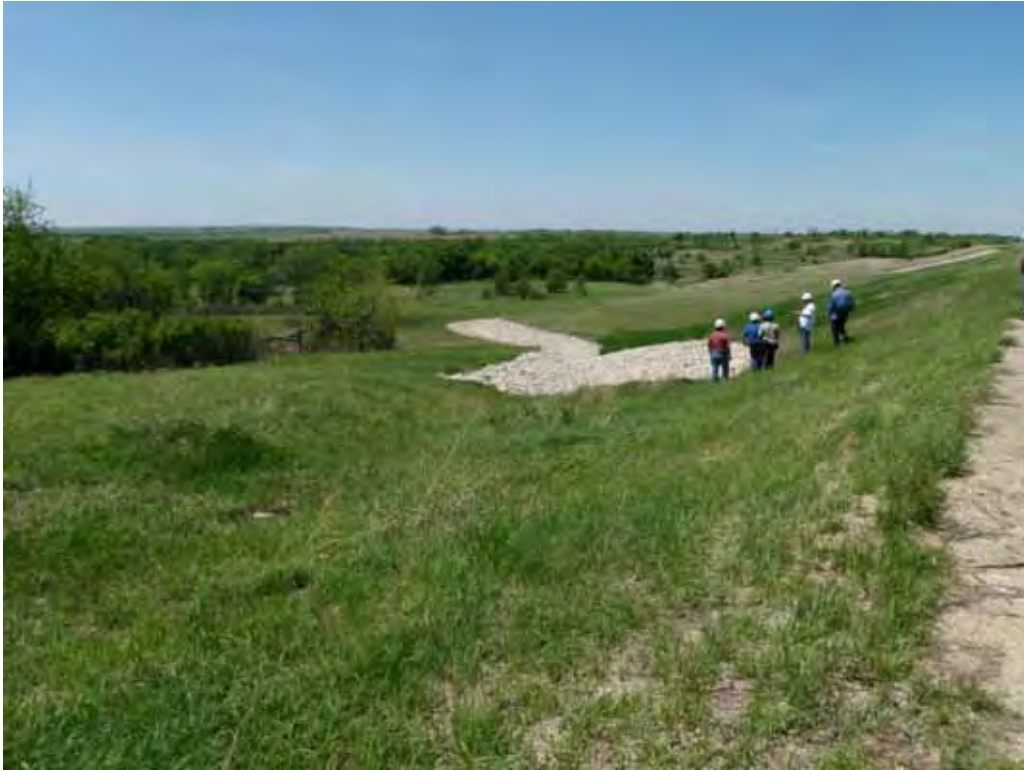
The toe drain was dry at the time of the assessment and appeared to be in good condition (Photos 11, 12, 14). Significant amounts of sediment were observed throughout the majority of the left toe drain channel (Photos 15, 17). The sediment deposits in the left toe drain channel appear to be from surface erosion observed near the left abutment and areas downstream of the dam. Only minor amounts of sediment were observed in the right toe

**Photo 11 - Left Toe Drain Ditch – Looking downstream at left toe drain ditch from top of left abutment.**

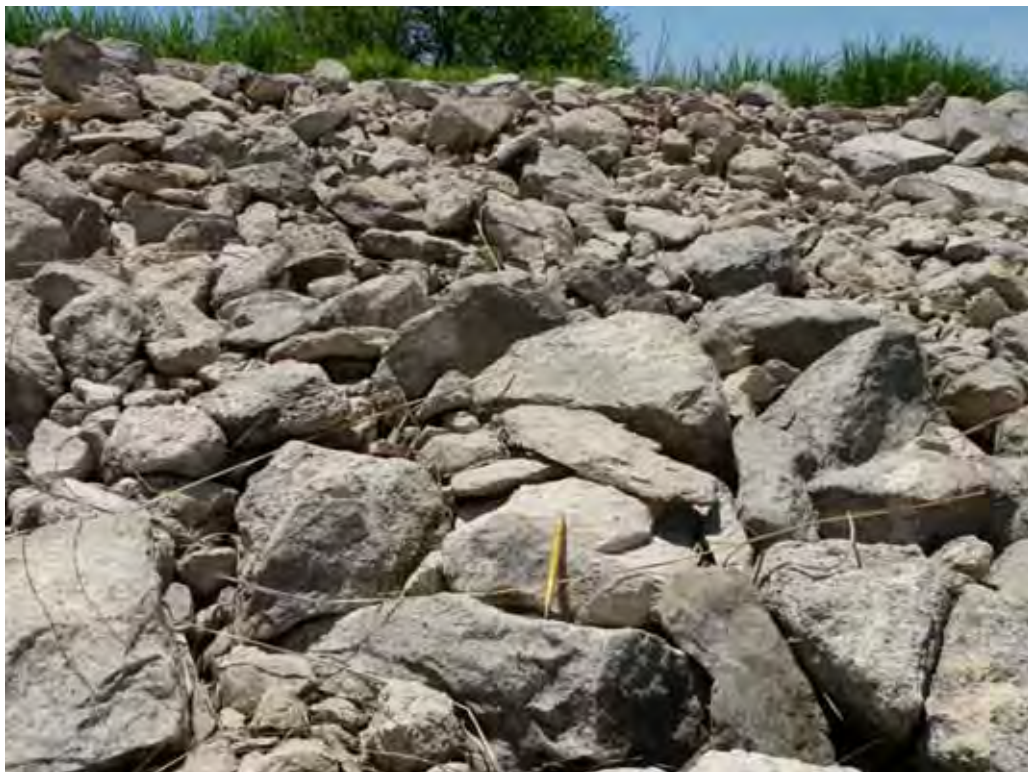
**Photo 12 - Left Toe Drain Ditch – Detail and scale of riprap slope protection typical in the toe drain channel.**

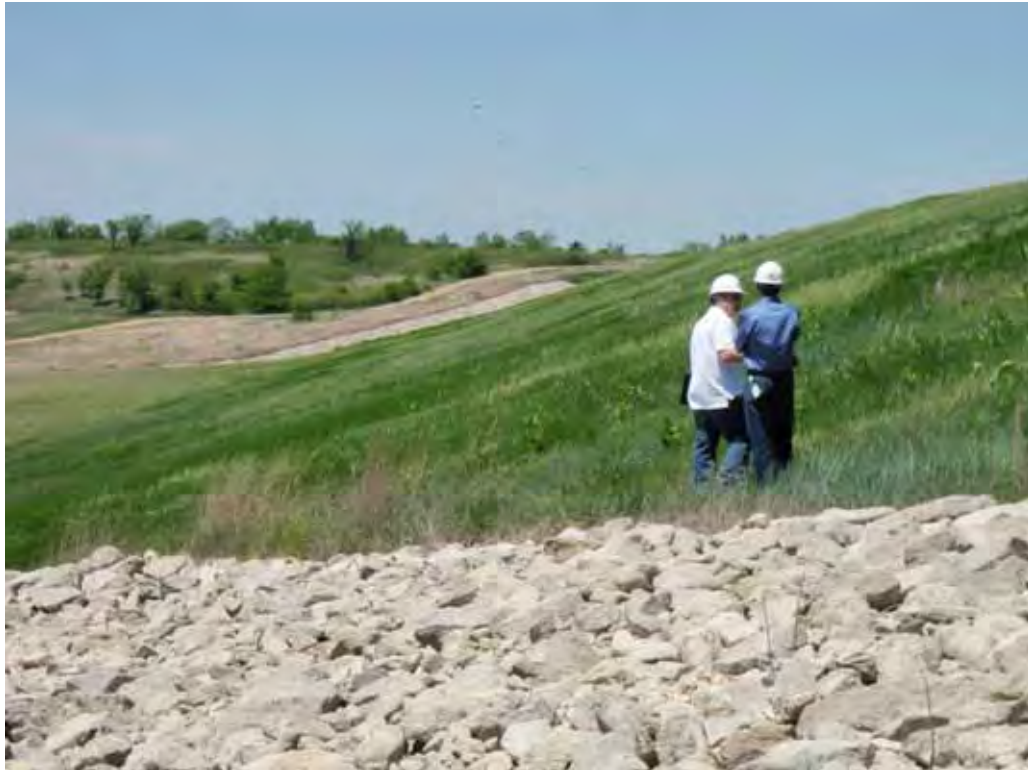
The downstream slope of the dam has a well-established stand of grass, which provides some erosion protection. No obvious signs of slumping, instability or significant erosion were observed on the downstream slope (Photos 13, 16, and 18). A broken monitoring well (PB-13) was observed on the right side of the downstream slope, some minor erosion was observed beneath the concrete pad of the well (Photo 24). Additionally, a few small trees were observed on the downstream slope of the stability berm near the toe drain (Photo 21) that should be removed.

**Photo 13 - Downstream Slope – Looking across the downstream slope from left toe drain ditch.**

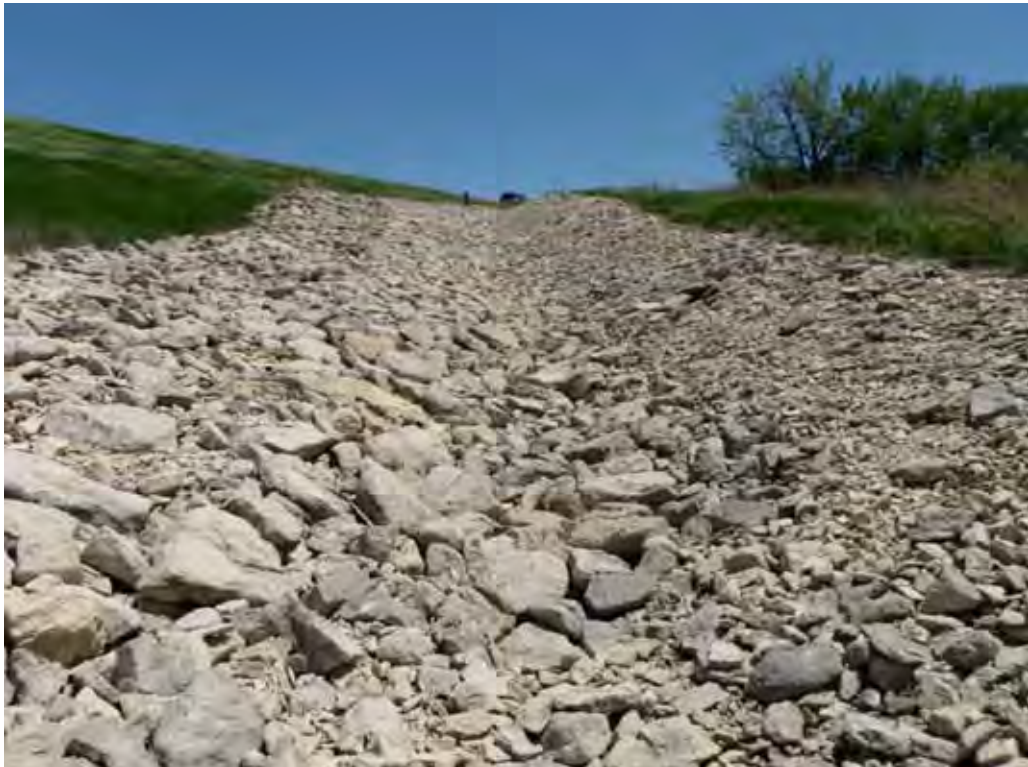
**Photo 14 - Left Toe Drain Ditch – Looking up left toe drain about halfway down channel.**

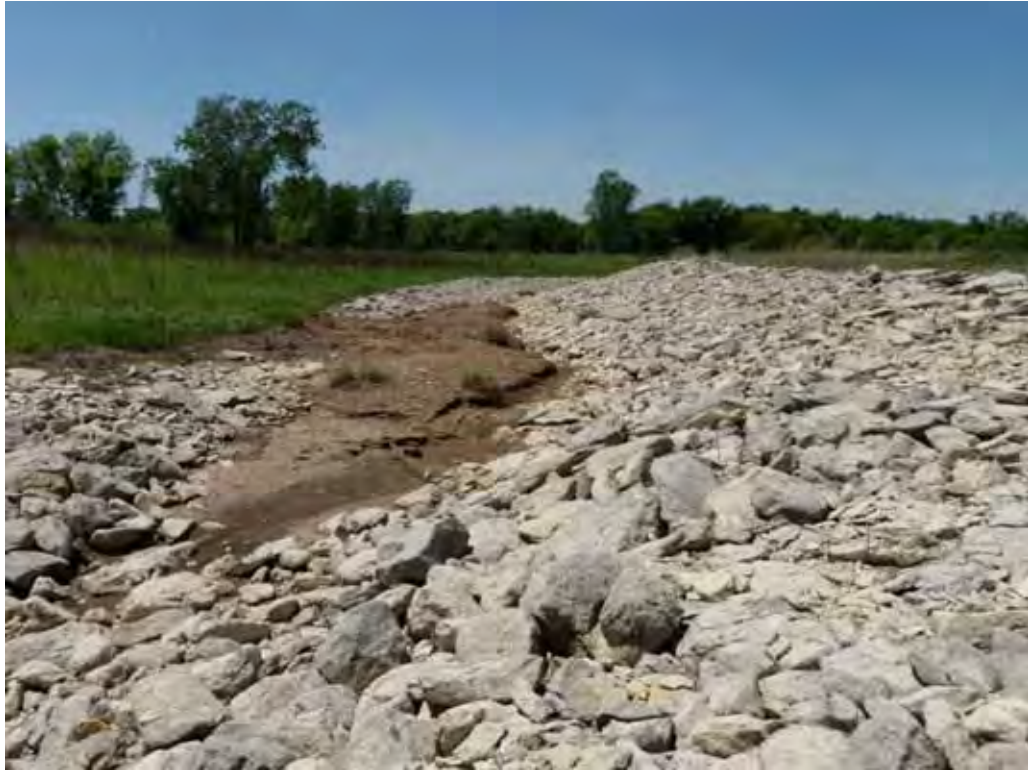
**Photo 15 - Left Toe Drain Ditch – Looking at sediment deposits in left toe drain ditch, before curve in channel at the toe of the stability berm.**

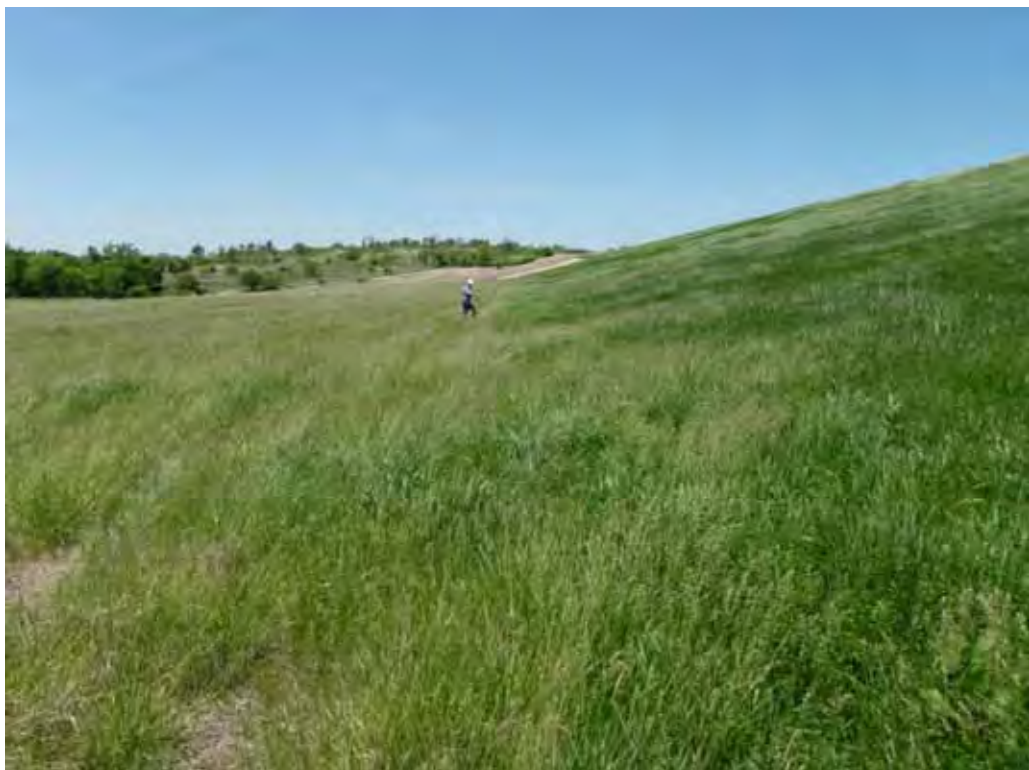
**Photo 16 - Downstream Slope – Looking towards right abutment, standing at the groin between the downstream slope and stability berm.**

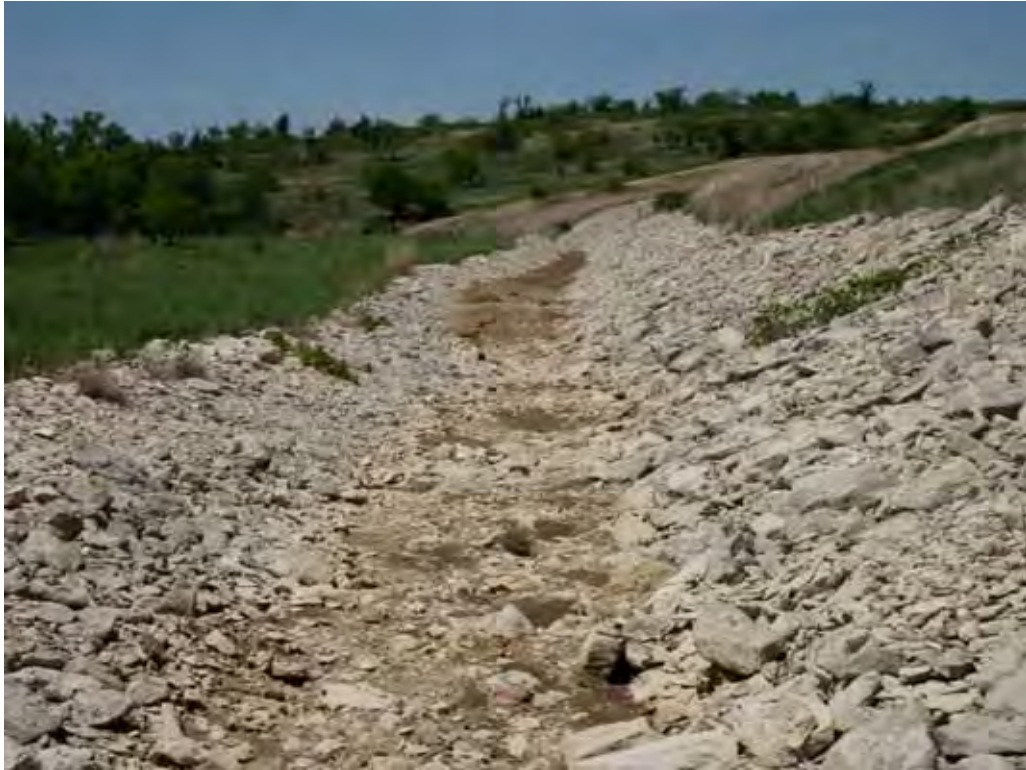
**Photo 17 - Left Toe Drain Ditch – Looking towards dam centerline along toe drain (Note: sediment along channel).**

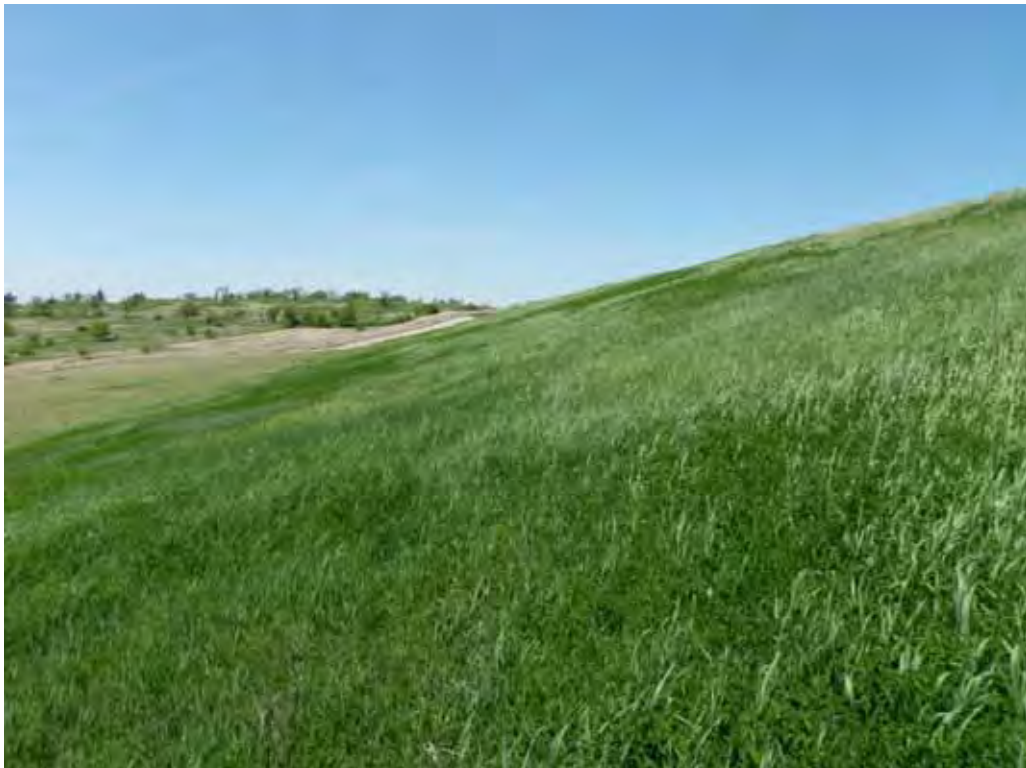
**Photo 18 - Downstream Slope – Looking towards right abutment on downstream slope, about halfway up slope.**

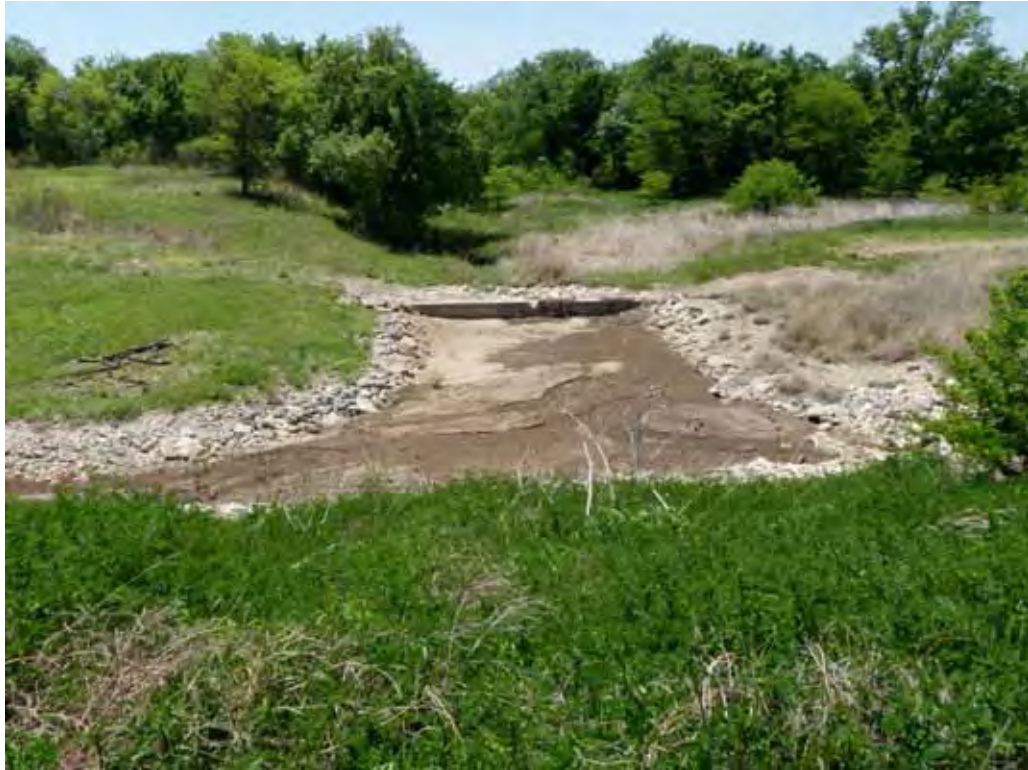
**Photo 19 - Toe Drain V-Notch Weir – Looking downstream towards toe drain and V-notch weir, standing on top of stability berm. (Note: Significant sediment buildup).**

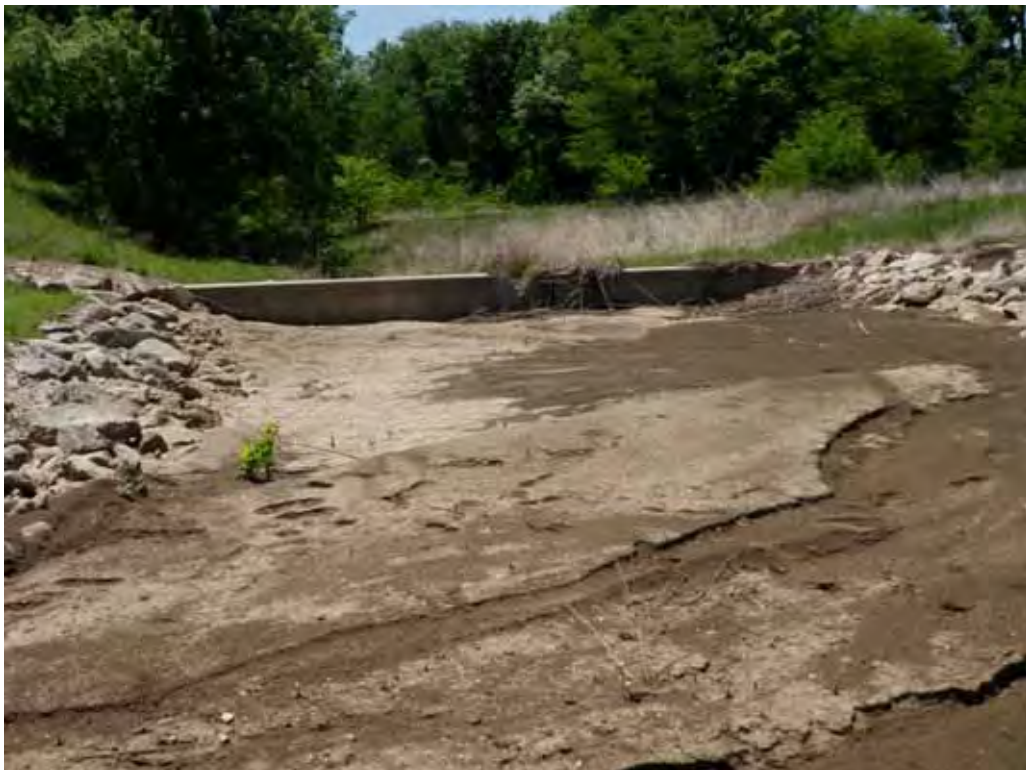
**Photo 20 - Toe Drain V-Notch Weir – Close up of V-notch weir looking downstream. (Note: Significant sediment buildup).**

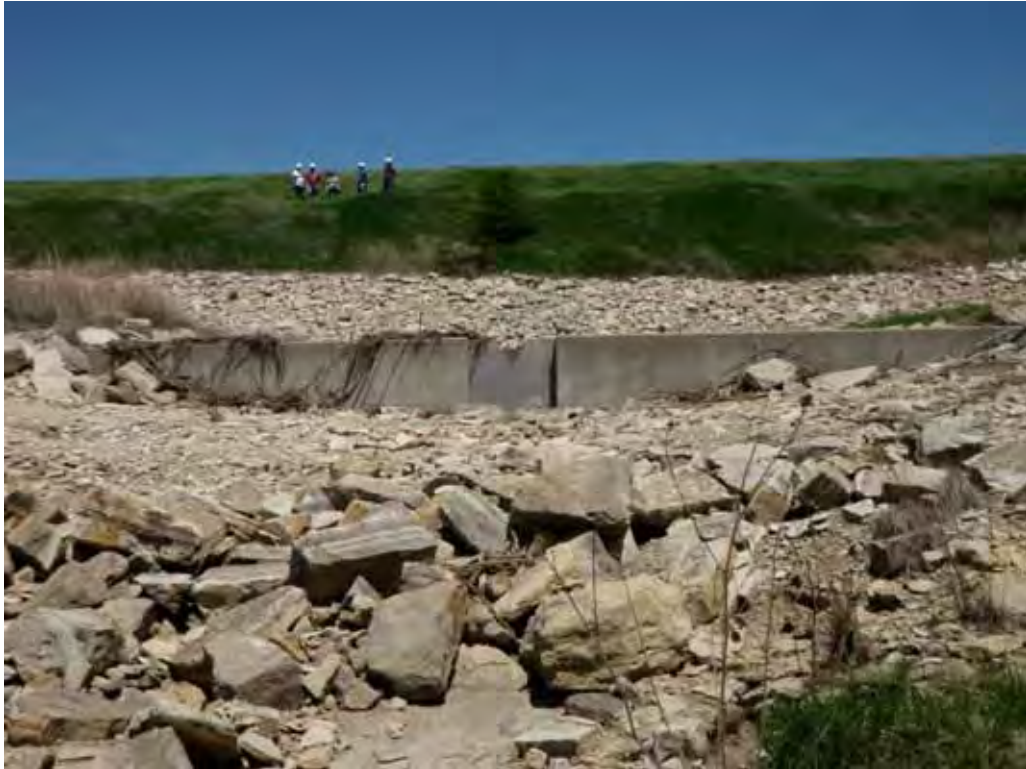
**Photo 21 - Toe Drain V-Notch Weir – Close up of V-notch weir looking upstream. (Note: Small tree at toe of stability berm).**

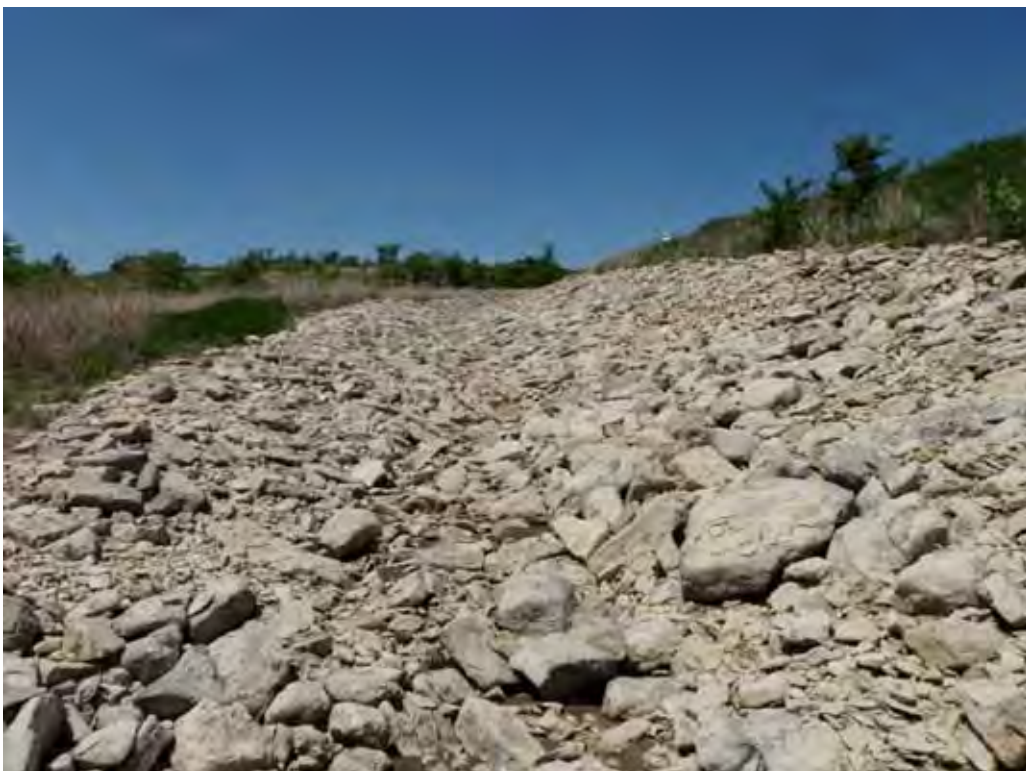
**Photo 22 - Right Toe Drain Ditch – Looking upstream at right toe drain ditch, standing at end of right ditch. (Note: Only minor sediment buildup in right ditch).**

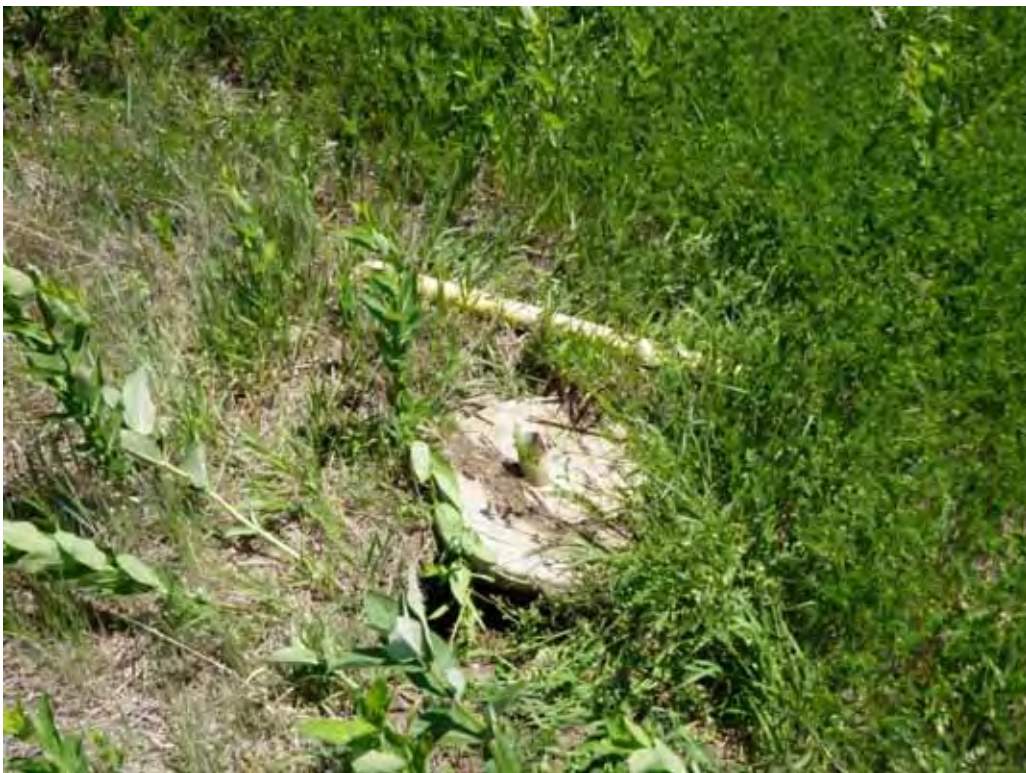
**Photo 24 - Downstream Slope – Looking at broken instrumentation marker on right side of downstream slope. (Note: Minor erosion under instrumentation marker).**

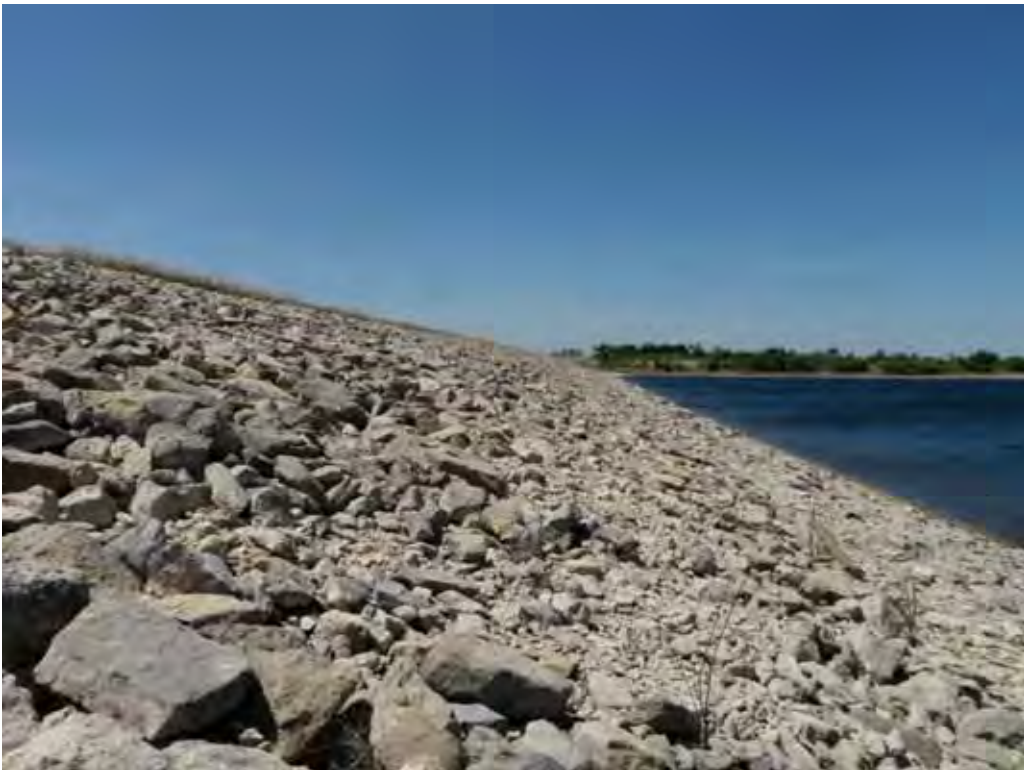
The upstream slope of the dam is protected by riprap and appeared to be in satisfactory condition. No vegetation or signs of instability were observed along the upstream slope (Photos 30 – 33). However, noticeable weathering and deterioration of the riprap was observed near the normal operating pool elevation, this is likely due to wave and freeze/thaw action (Photo 31).

**Photo 30 - Upstream Slope – Looking towards right abutment, standing about halfway up the upstream slope of dam.**

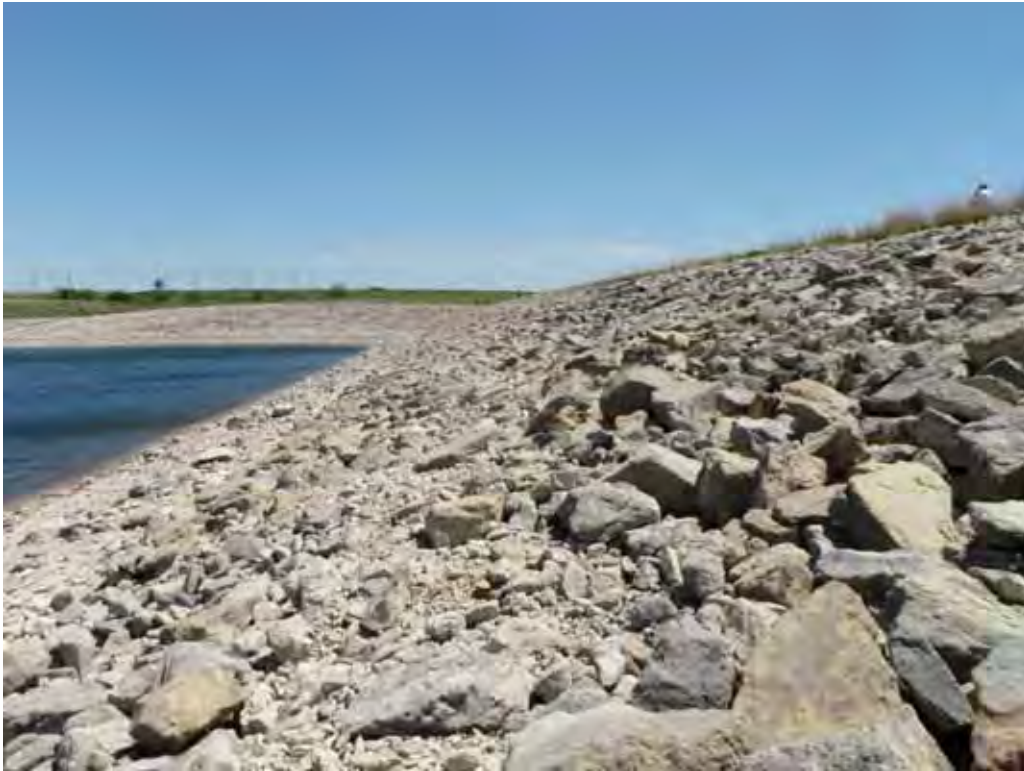
**Photo 31 - Upstream Slope – Looking towards left abutment, standing about halfway up the upstream slope of dam.**

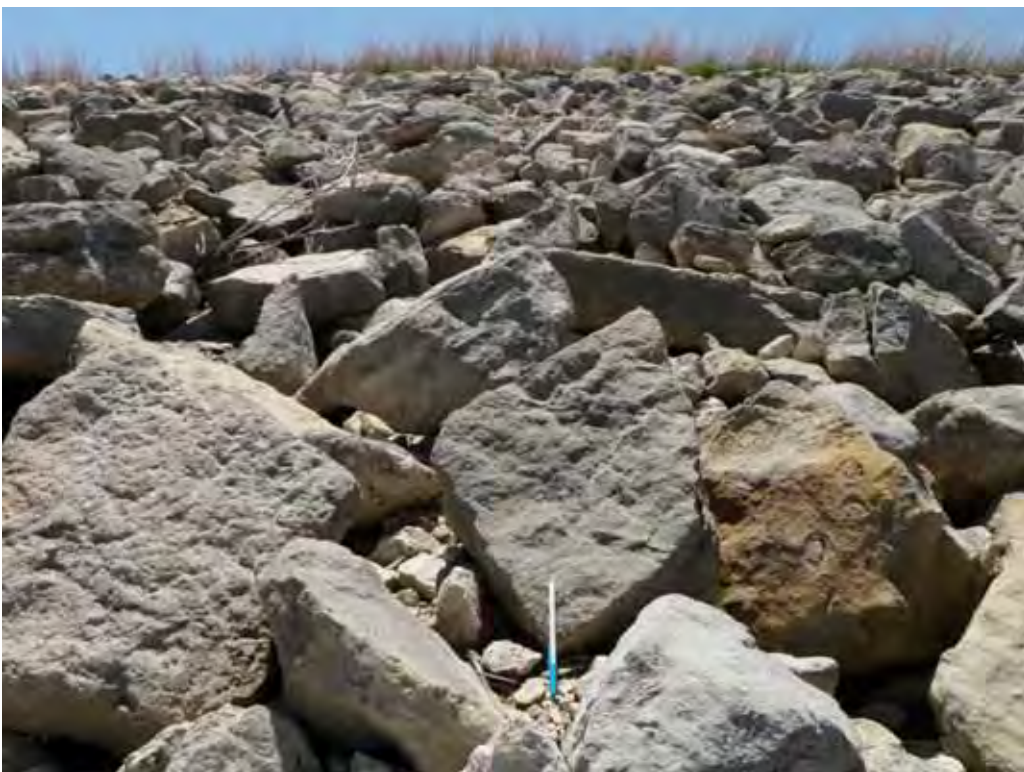
**Photo 32 - Upstream Slope – Detail and scale of riprap slope protection on upstream slope of dam.**

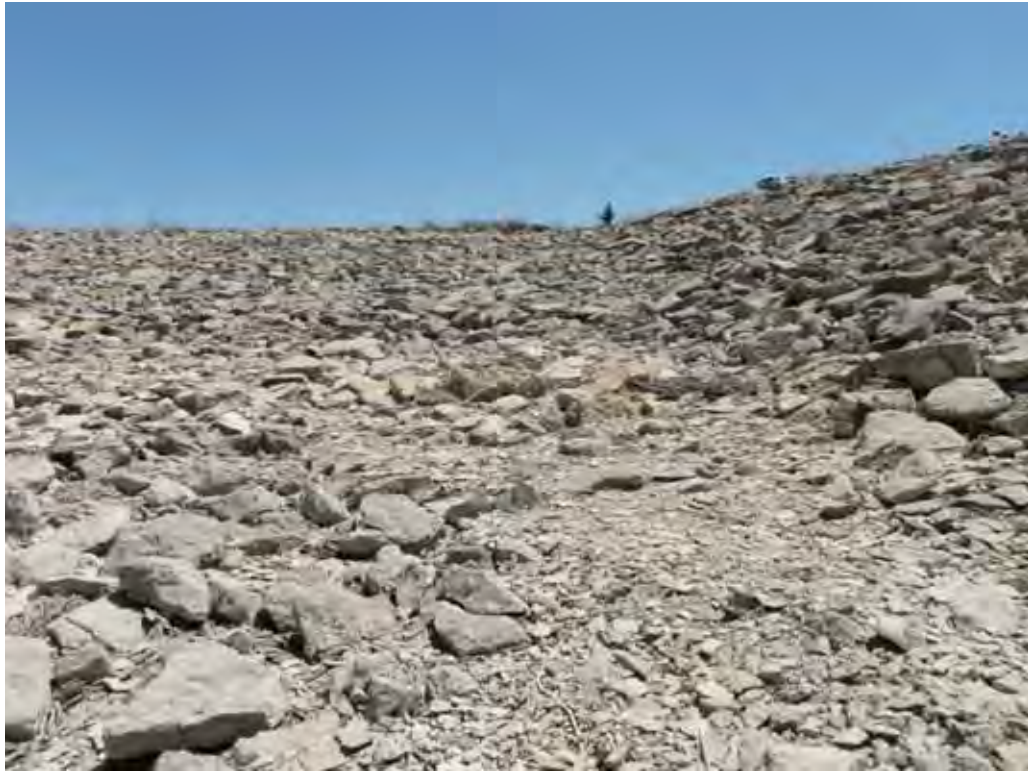
**Photo 33 - Upstream Slope – Looking up the left abutment near the waters edge.**
